## Water Main Pipe At Australian Steel Mill Repaired With DuraWrap

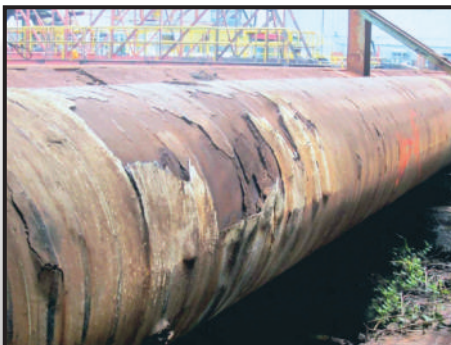
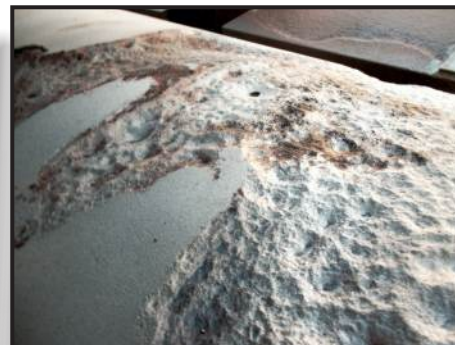
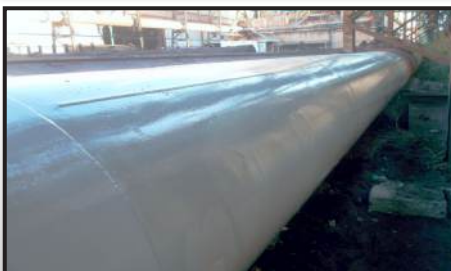
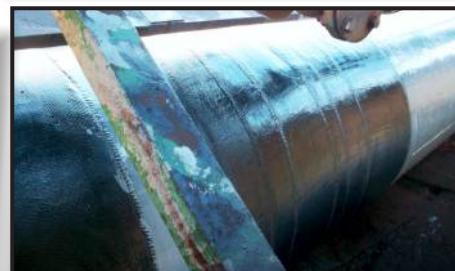
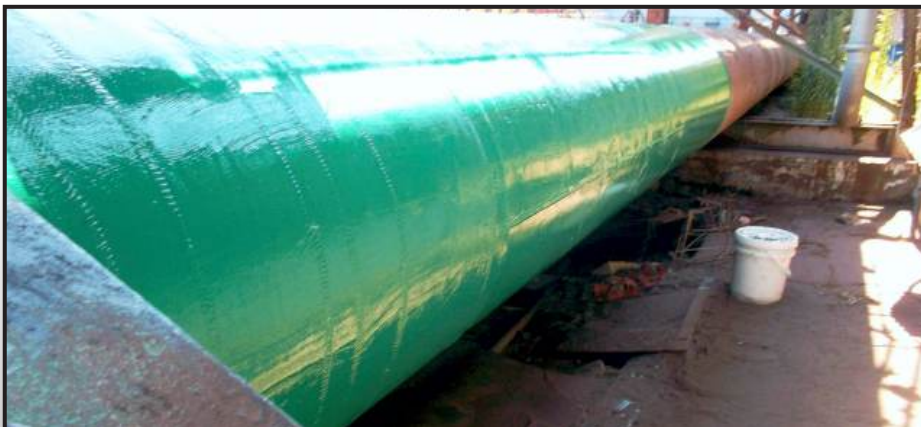
This water main pipe located at an Australian steel mill was constantly exposed to hypochlorite fall out from a nearby cooling tower as well as being in contact with sludge from the mill's process.

Even though the pipe was previously repaired with a 'tape-like' product, the pipe was showing signs of advanced corrosion in this aggressive chemical environment.

The proposed repair method required abrasive blasting to remove all traces of the old, failed protective wrap and the corrosion.

*CeramAlloy CP+AC* was first used to repair the heavily corroded areas of the pipe. This was followed by an application of the *DuraWrap Carbon Fiber Pipe Wrap System*, because of its extraordinary physical properties.

After full cure was achieved, the pipe was then protected with a custom colored *CHEMCLAD GP* to protect the pipe from exposure in this harsh environment.
