## Ceramics Factory Roof in the Philippines Repaired & Protected With ENESEAL HR

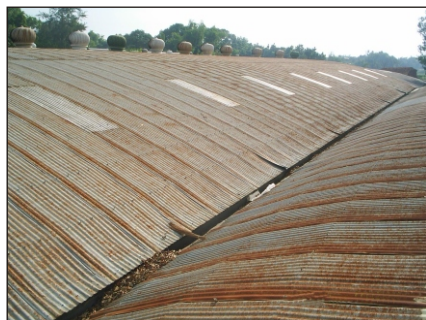
This ceramics factory, located near Manila, had a badly corroded metal roof with hundreds of holes in it. Water would drip all over the factory during the rainy months. The factory workers would routinely squeeze into the sections of the factory where there was no water dripping!

**Note the holes in roof.**

After cleaning the roof, self-adhesive fiberglass mesh was applied over all the holes in the corrugated metal sheets. This was followed by a two-coat application of ENESEAL HR.
