## 60 Year Old Francis Turbine Casings Are Saved By DuraWrap

A major power station in Bavaria had a serious issue with these two 60 year old Francis turbine casings. They were in very poor condition – structurally compromised and leaking.

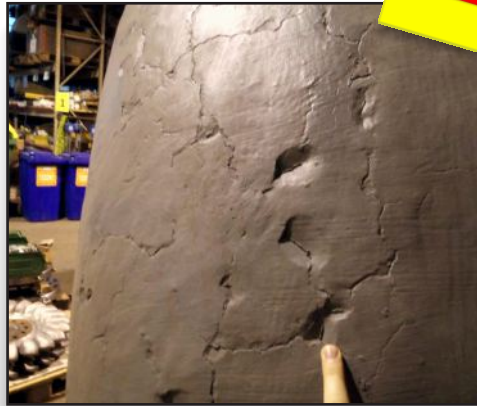
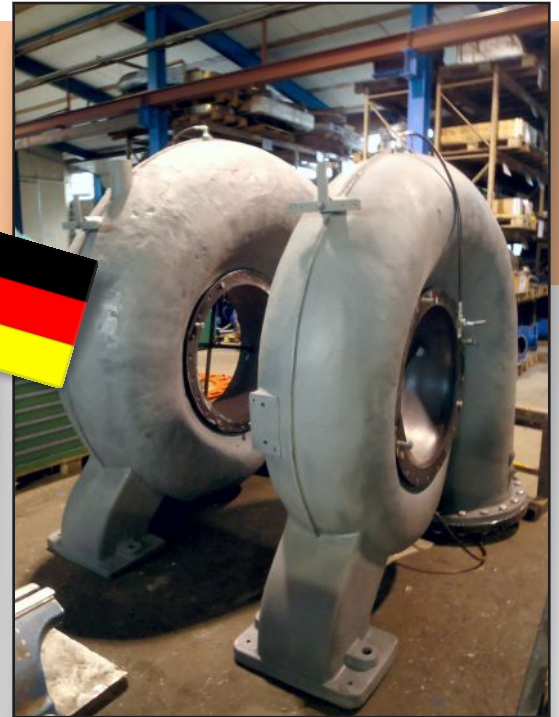
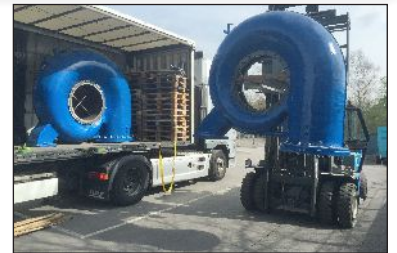
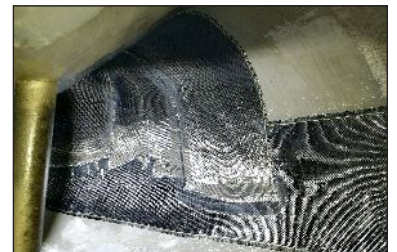
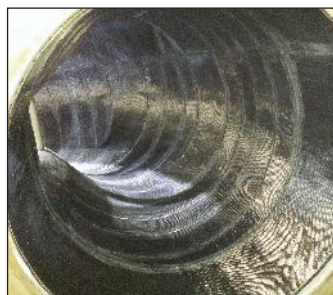
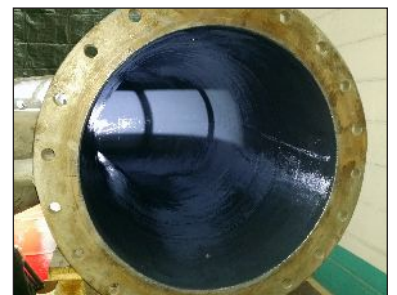
ENECON Germany were called in to see if they could refurbish these casings which weighed about 2 tons each. The power station engineers were worried that due to metal fatigue, the casings would no longer be able to withstand the operating pressures and, at some point, they could fail causing catastrophic damage to the turbine.

The casings were grit-blasted and then **METALCAD DurAlloy** was used to seal the leaks and rebuild all the metal back to the original thickness, shape and contour.

The **METLACLAD DuraWrap** system was then applied on the *interior* of the turbine casings in order to reinforce and restore their structural integrity.

**CHEMCLAD XC** was applied over the **DuraWrap** to provide a smooth surface finish in order to restore/improve the components' efficiency.
