## ENECRETE & CHEMCLAD Are Used To Repair & Protect Concrete Effluent Tank

This damaged concrete effluent tank is located at an explosives company in Australia. The effluent water inside of this tank contains cyanide and ammonium nitrate.

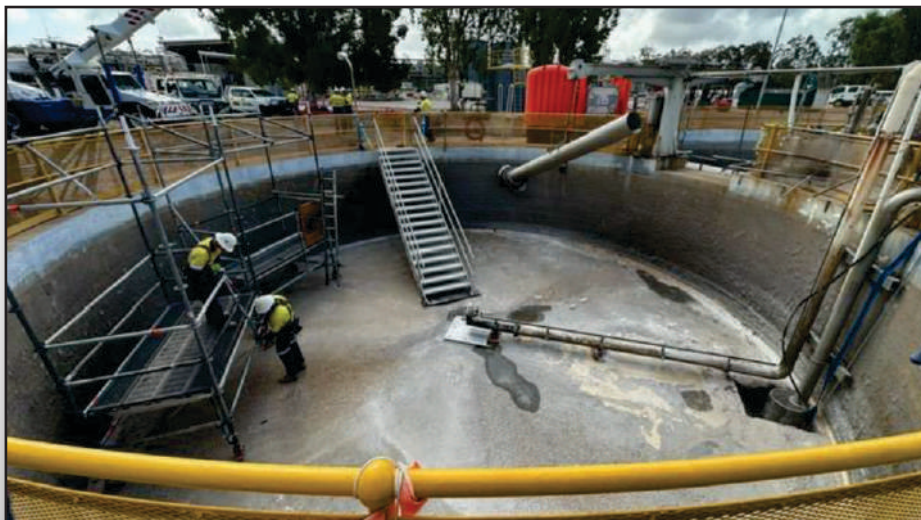
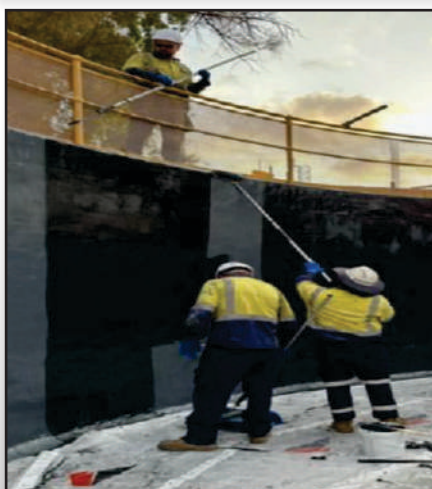
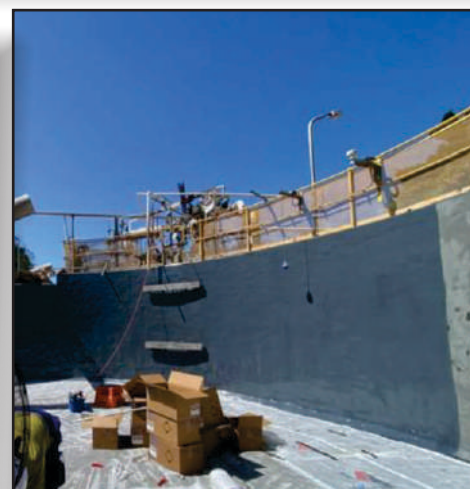
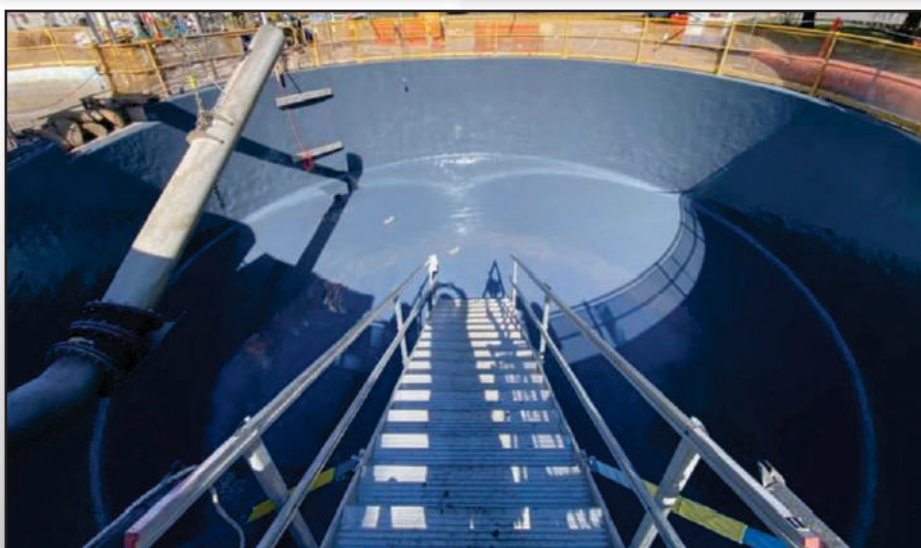
After years in service the concrete floor and wall were showing signs of deterioration from chemical attack. ENECON's Exclusive Distributor in Australia was contacted and asked to provide a solution to this problem.

All the effluent water was

drained from the tank and the existing pipework leading into the tank was temporarily disconnected.

The entire surface of the floor and wall were rebuilt to the original specification using ENECRETE DuraQuartz.

After the DuraQuartz fully cured, two coats of CHEMCLAD XC were applied to the floor and wall to prevent future chemical attack.
